ROOF REPORT

Customer Name: [REDACTED]
 Customer Order: 71967
 Site Address: [REDACTED]
 Site Contact: Roof Plumber
 Scope of works: Please provide a photo roof report, including photos of any safety equipment used on site.

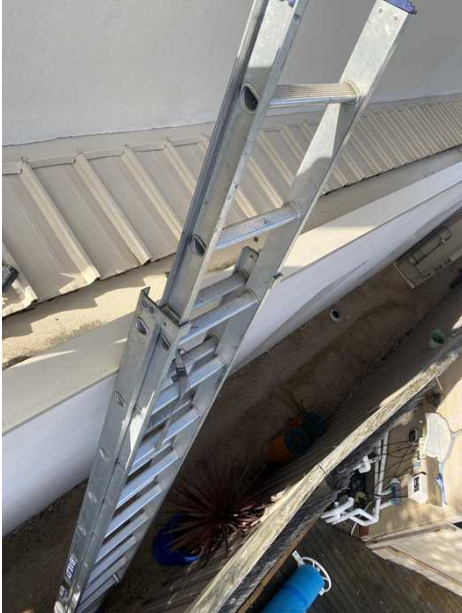
Ladder setup & tied off.

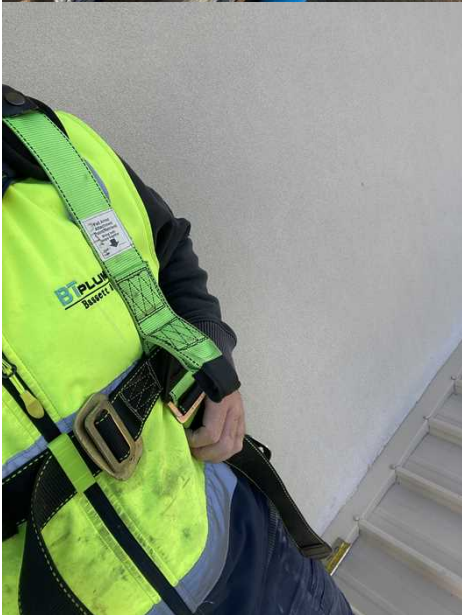
Safety harness in use.

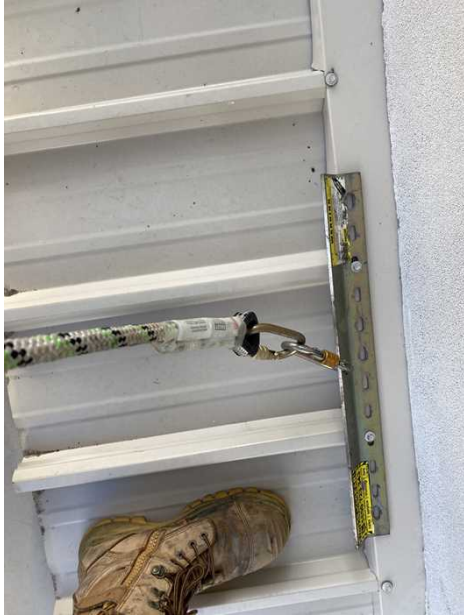
Harness anchor used.

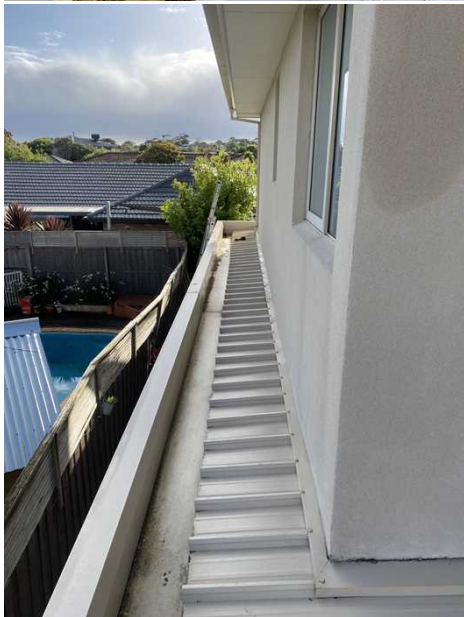
North end lower roof above leak.

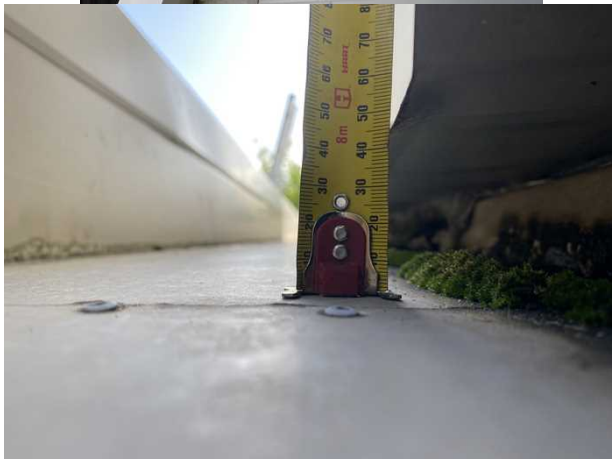
Box gutter depth non compliant measuring 45mm.

Replacing problem areas to conform with Aus Standards.

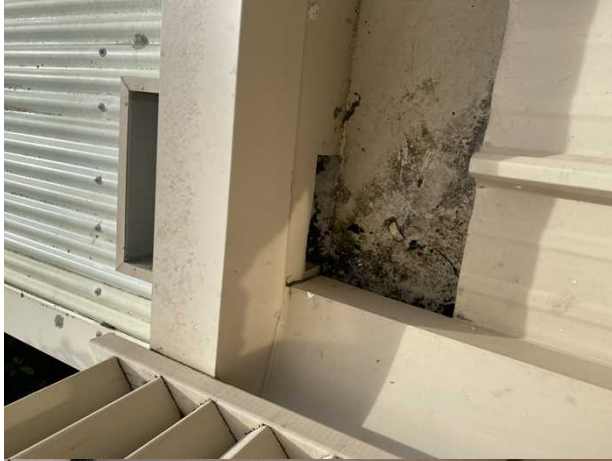
Box gutter chute non compliant discharging out through the side of the gutter causing gutter pooling.

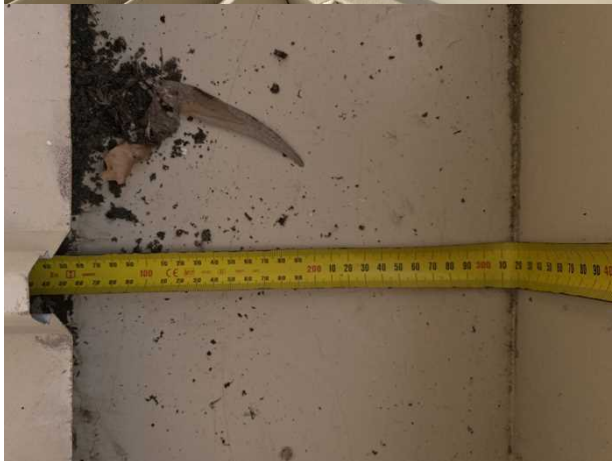
Box gutter width ok - 310mm.

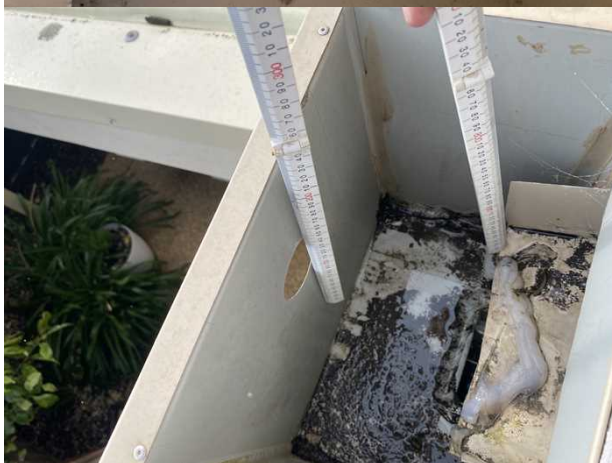
Rainhead overflow non compliant approx 140mm above the weir of the box gutter.

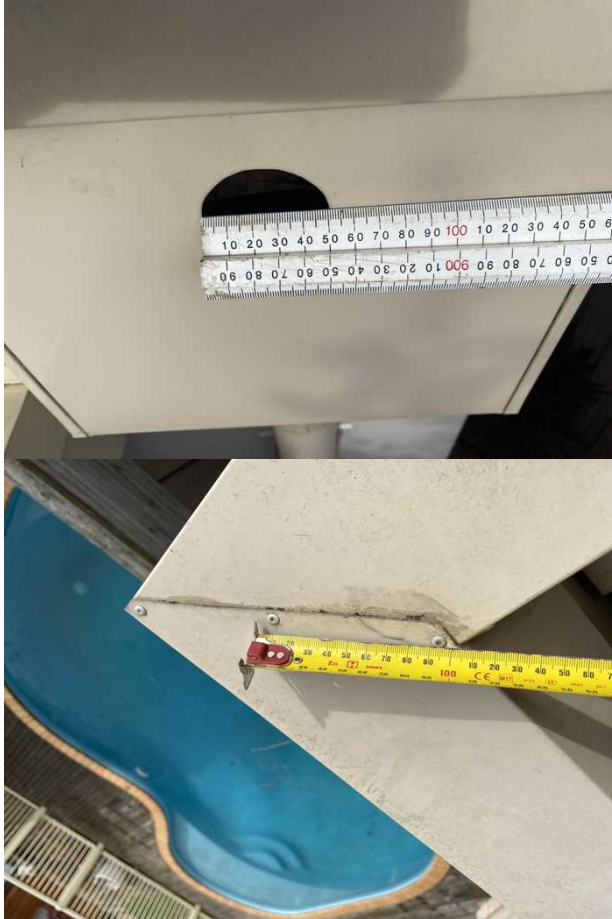
Rainhead overflow non compliant 45mm round.

Fixing spacings on cappings & flashings non compliant (40mm) at 95mm spacing.
